HAUL TRUCK A-FRAME & PUMP MONITORING

The customer has experienced systemic A-frame bearing failures on their entire haul truck fleet. The customer installed the GreaseBoss Critical Point monitoring and Bulk Flow Management solutions on two haul trucks.

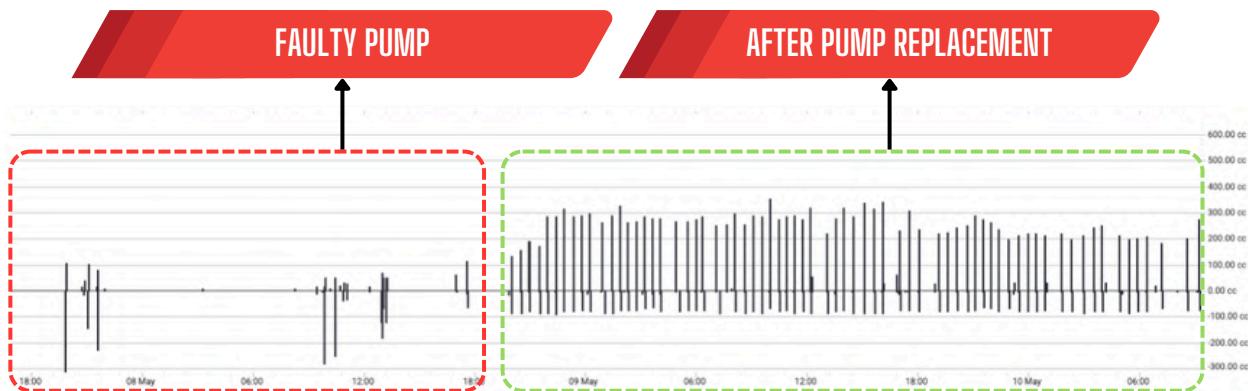
TRUCK 1 - ENDPOINT BF AT PUMP

GREASEBOSS DATA REVEALED FAULTY GREASE PUMP

Within hours of driving out of the workshop bay, the GreaseBoss data showed that the truck pump was erratic on timing and variable volumes. The A-frame bearing data aligned exactly with the pump data, indicating that this was a pump issue.

The maintenance team inspected and found the A-frame bearing dry and the failed grease pump. A new grease pump was installed.

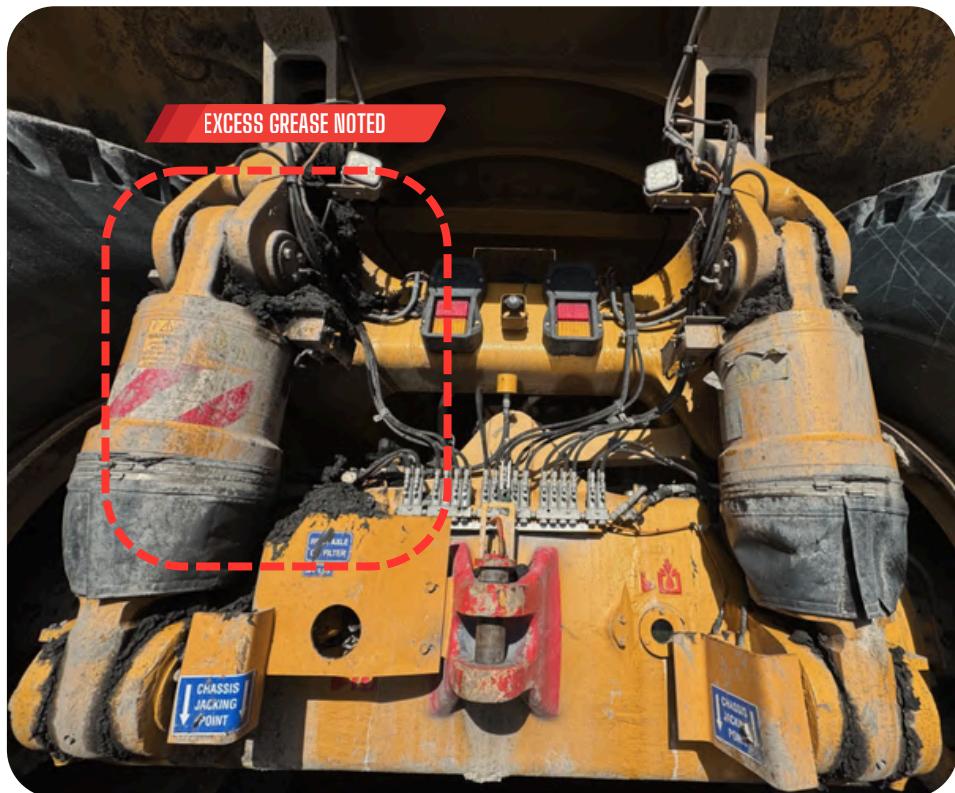
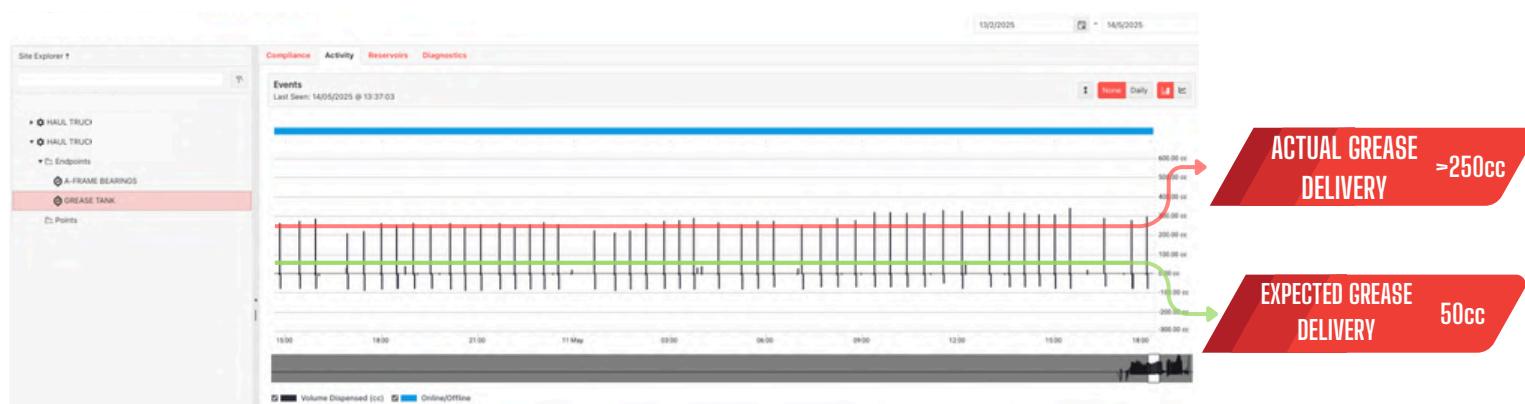
GREASEBOSS DATA REVEALED EXCESS GREASE BEING DISPENSED

After the pump was replaced, another issue became immediately apparent. The truck has 30 injectors set at 1.3cc and 1 x injector at 5cc for the A-Frame. The expected grease volume is approximately 50cc per cycle (refer below on #TR207 pump volumes).

GreaseBoss data showed 250+cc being dispensed each pump cycle - 5 times the expected amount.

GreaseBoss and the site maintenance team were able to use this data to determine that the truck had numerous bypassing injectors. This was confirmed by inspections showing excessive grease on some components. The truck was then scheduled for further maintenance to replace all faulty injectors.

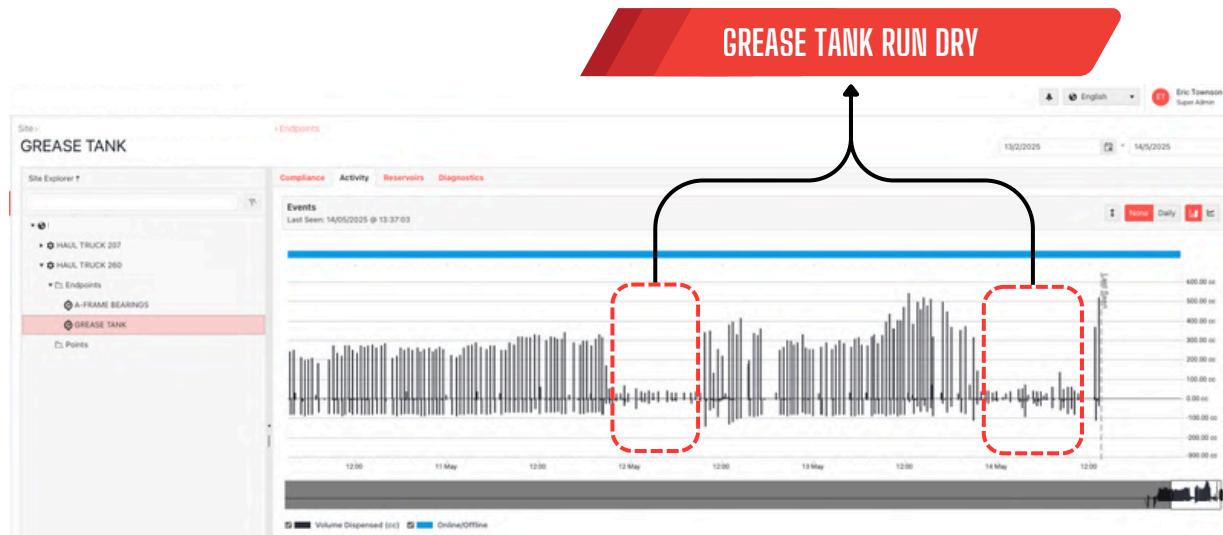
INDICATED EMPTY GREASE TANK

Due to the higher-than-expected grease volume being pumped into the truck's lube system, the grease tank ran dry twice, both times this was detected by the Endpoint BF data, allowing the team to schedule an ad-hoc grease tank refill, limiting the amount of time that the truck operated without grease to 12 hours each time. The standard grease tank filling regime was for fortnightly fills, so **without this visibility, this truck would have operated without grease for approximately 250 hours every fortnight (approx. 75% of the time)**.

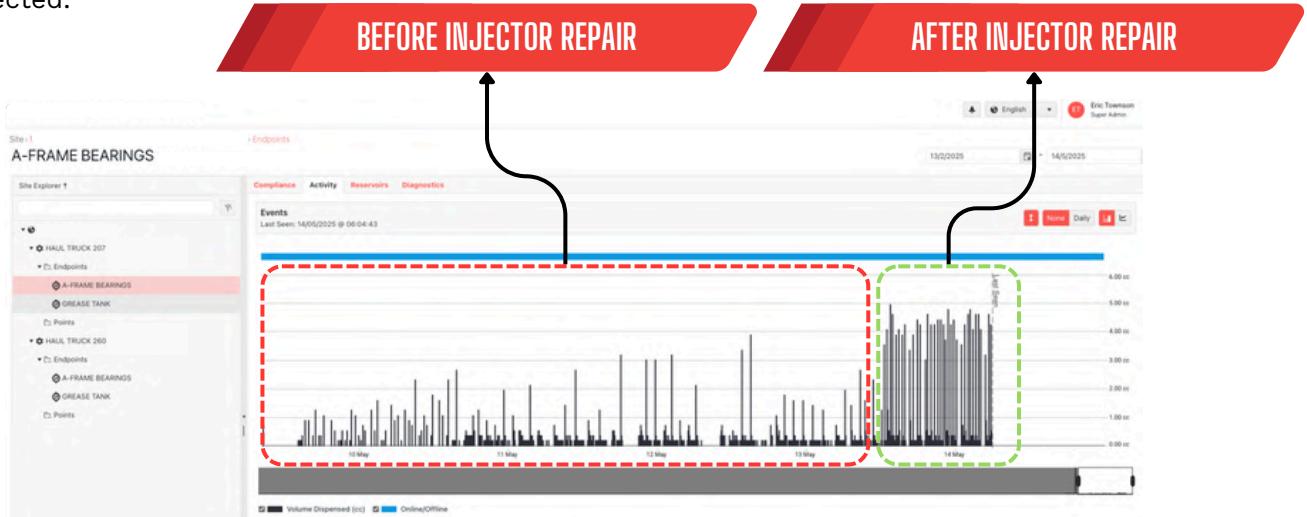
HIGHLIGHTED ERRATIC GREASE TO THE A-FRAME BEARING

Immediately after installation, the GresaeBoss data revealed that the A-Frame bearing was not receiving the expected 5cc per pump cycle. Data highlighted erratic grease to the A-Frame bearing rather than the expected, consistent injector volume. Site investigated and found the **injector had been incorrectly installed and tuned**. Once the injector was correctly installed and tuned, it behaved as expected.

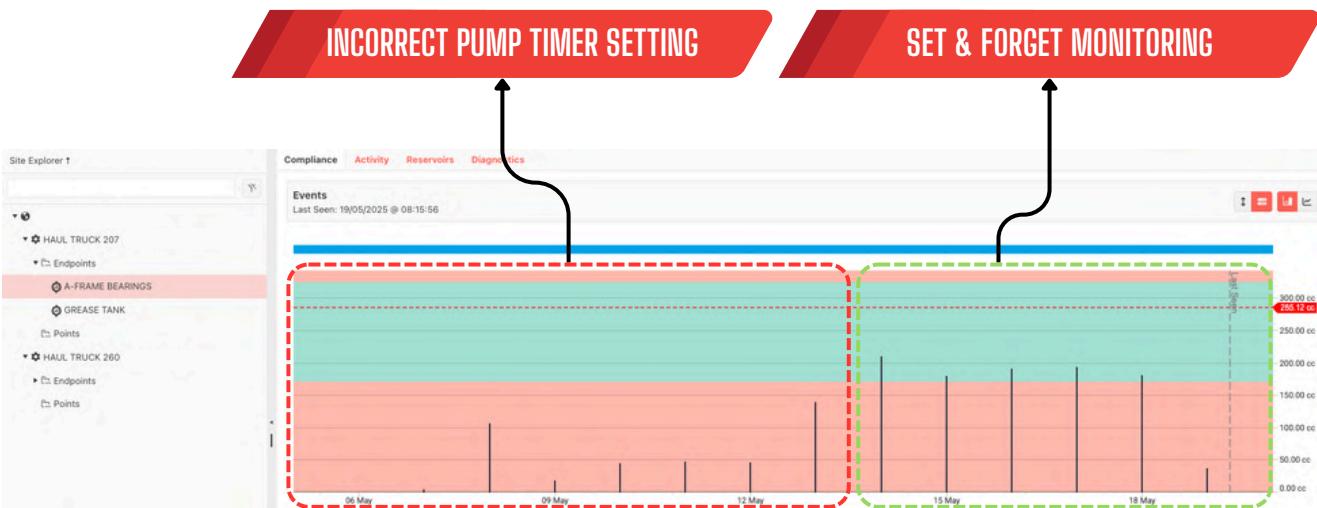
DETECTED INCORRECT PUMP TIMER SETTING

The GreaseBoss data indicated that the pump cycle time was running at over 60 minutes, instead of the desired 30 minute cycle. The maintenance team investigated and corrected the pump setting to 30 minute cycles.

After making these informed improvements to Truck 2's lubrication system, the truck is now being lubricated as expected and the automatic monitoring and alerting has been enabled. This automatic monitoring allows the maintenance team to now set and forget. Ongoing monitoring will ensure that the site's maintenance team are alerted if the truck's lubrication falls out of the set specifications.
