# HAUL TRUCK A-FRAME & PUMP MONITORING

The customer has experienced systemic A-frame bearing failures on their entire haul truck fleet. The customer installed the GreaseBoss Critical Point monitoring and Bulk Flow Management solutions on two haul trucks.

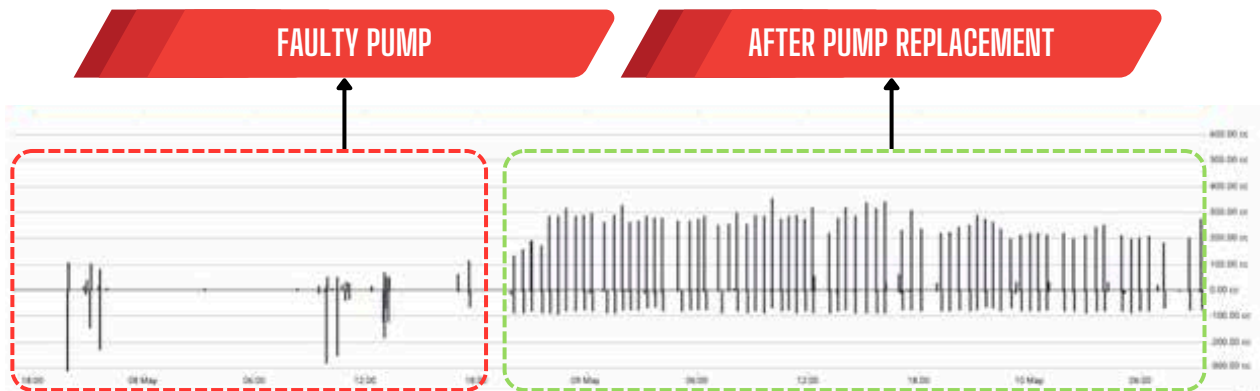
### TRUCK 1 – ENDPOINT BF AT PUMP

Within hours of driving out of the workshop bay, the GreaseBoss data showed that the truck pump was erratic on timing and variable volumes. The A-frame bearing data aligned exactly with the pump data, indicating that this was a pump issue.

The maintenance team inspected and found the A-frame bearing dry and the failed grease pump. A new grease pump was installed.

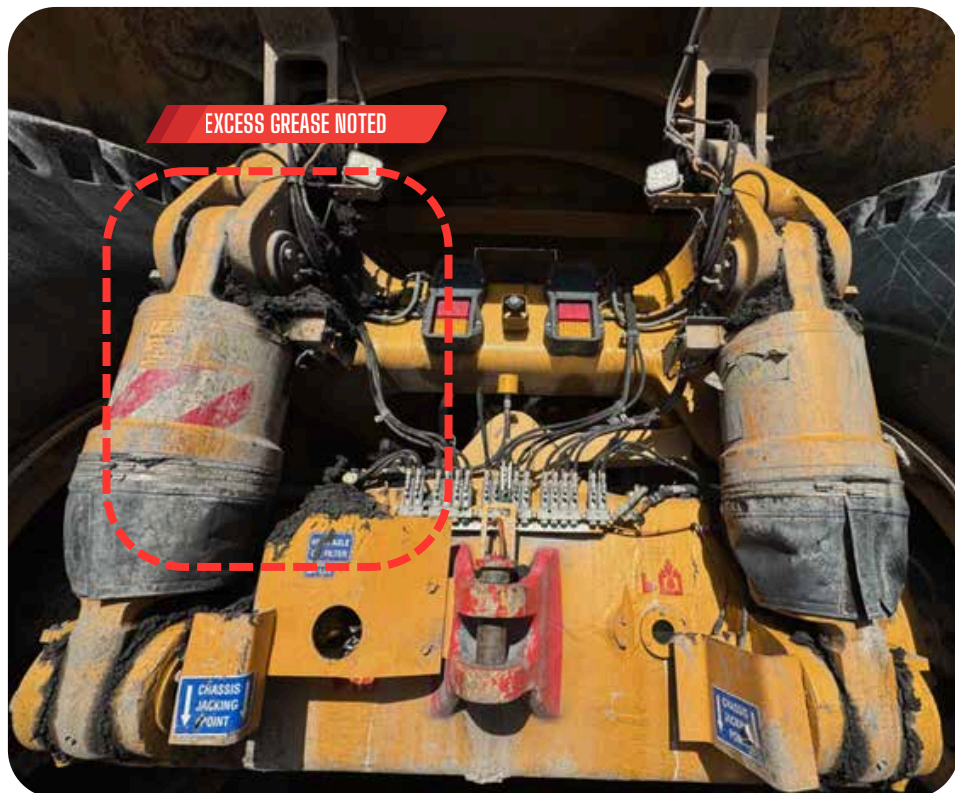
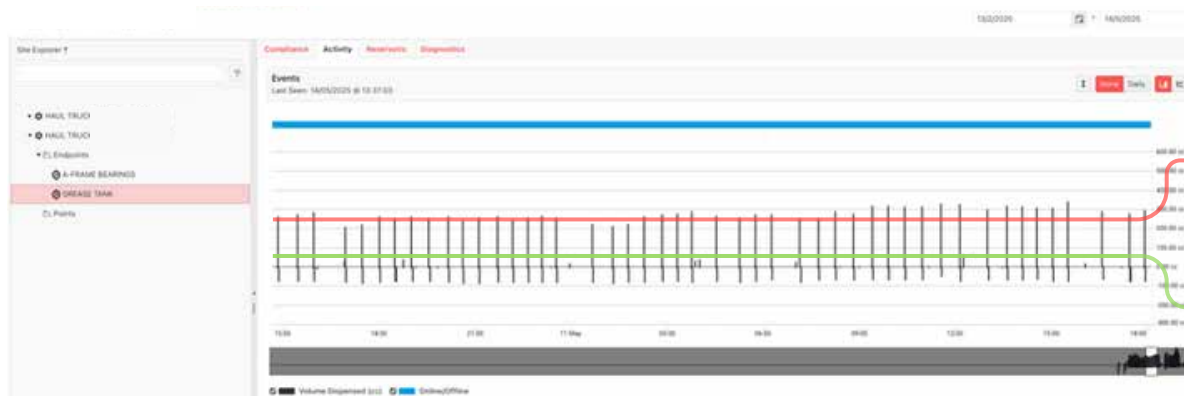
After the pump was replaced, another issue became immediately apparent. The truck has 30 injectors set at 1.3cc and 1 x injector at 5cc for the A-Frame. The expected grease volume is approximately 50cc per cycle (refer below on #TR207 pump volumes).

**GreaseBoss data showed 250+cc being dispensed each pump cycle - 5 times the expected amount.** GreaseBoss and the site maintenance team were able to use this data to determine that the truck had numerous bypassing injectors. This was confirmed by inspections showing excessive grease on some components. The truck was then scheduled for further maintenance to replace all faulty injectors.

**ACTUAL GREASE DELIVERY**  
≈250cc

**EXPECTED GREASE DELIVERY**  
50cc

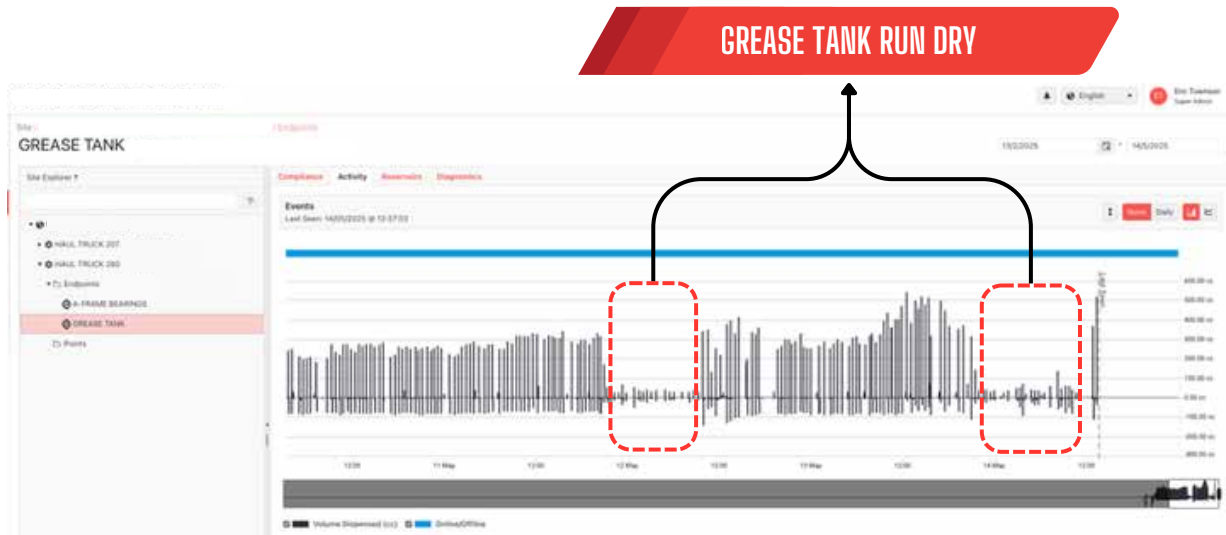
Due to the higher-than-expected grease volume being pumped into the truck's lube system, the grease tank ran dry twice, both times this was detected by the Endpoint BF data, allowing the team to schedule an ad-hoc grease tank refill, limiting the amount of time that the truck operated without grease to 12 hours each time. The standard grease tank filling regime was for fortnightly fills, so **without this visibility, this truck would have operated without grease for approximately 250 hours every fortnight (approx. 75% of the time).**

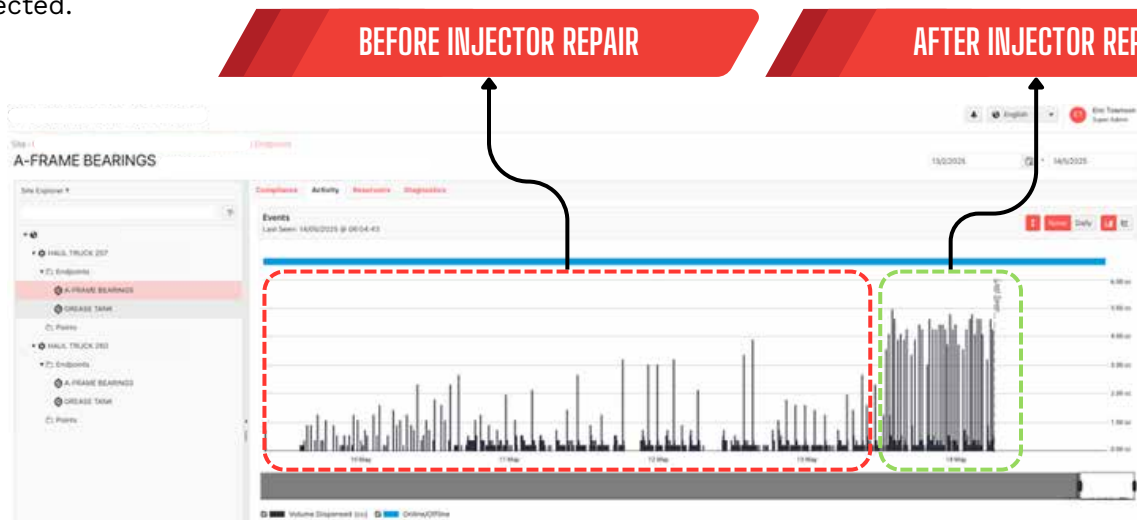
Immediately after installation, the GreaseBoss data revealed that the A-Frame bearing was not receiving the expected 5cc per pump cycle. Data highlighted erratic grease to the A-Frame bearing rather than the expected, consistent injector volume. Site investigated and found the **injector had been incorrectly installed and tuned.** Once the injector was correctly installed and tuned, it behaved as expected.

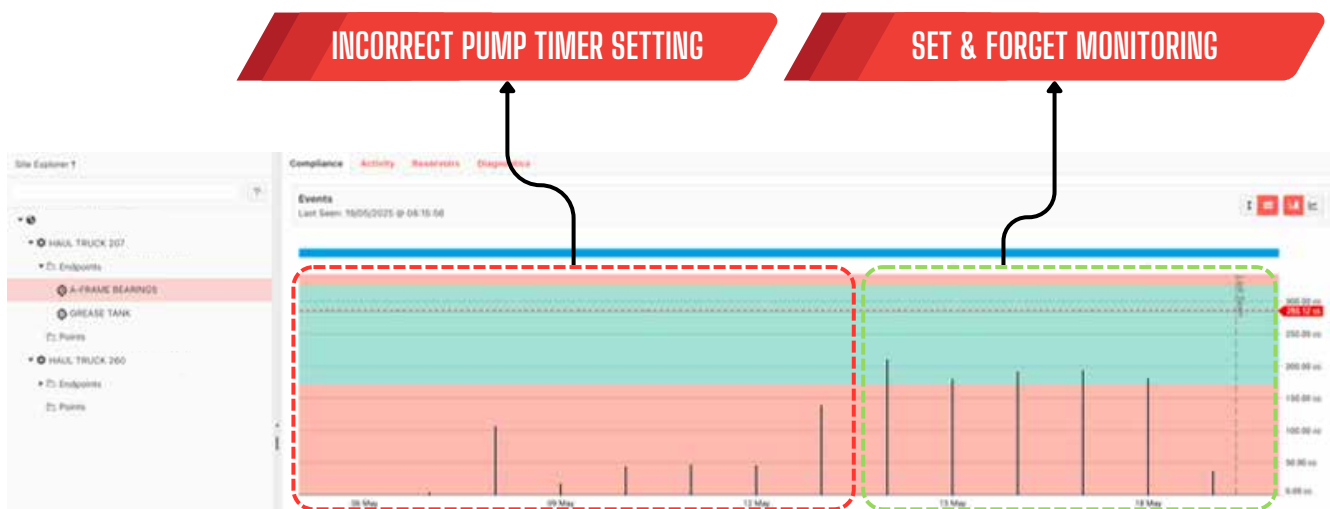
The GreaseBoss data indicated that the pump cycle time was running at over 60 minutes, instead of the desired 30 minute cycle. The maintenance team investigated and corrected the pump setting to 30 minute cycles.

After making these informed improvements to Truck 2's lubrication system, the truck is now being lubricated as expected and the automatic monitoring and alerting has been enabled. This automatic monitoring allows the maintenance team to now set and forget. Ongoing monitoring will ensure that the site's maintenance team are alerted if the truck's lubrication falls out of the set specifications.

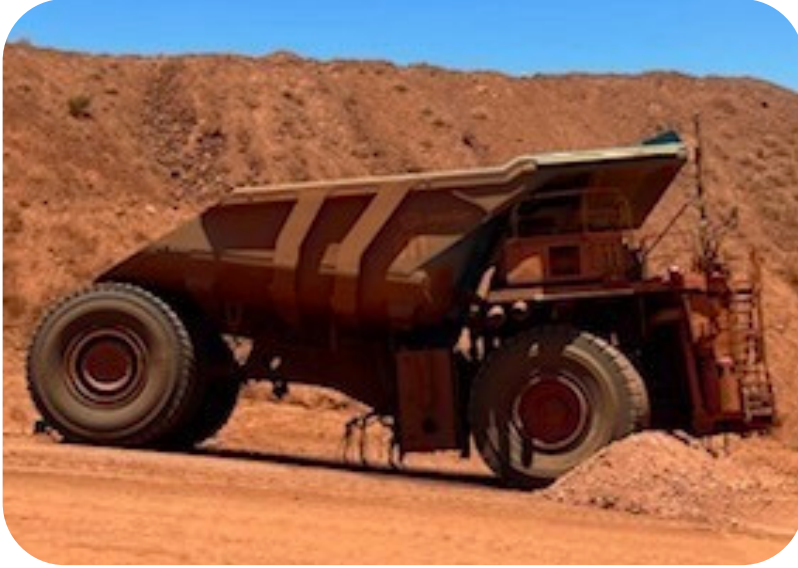
FAILED A-FRAME BEARING

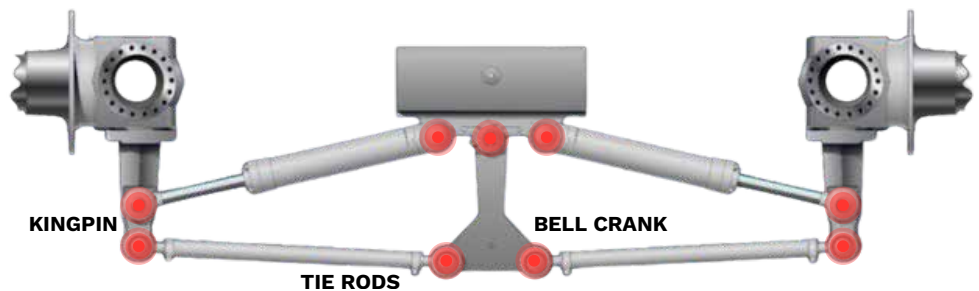
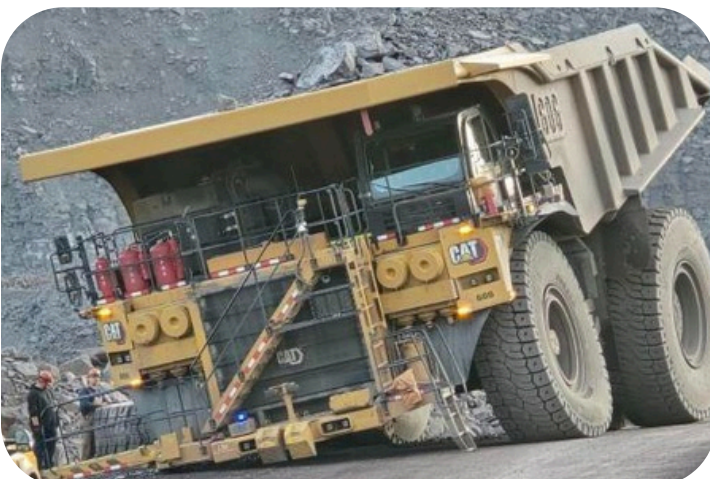
FAILED STEERING COMPONENTS
