EXCAVATOR BOOM FOOT & HOIST CYLINDER MONITORING - LIEBHERR 9600

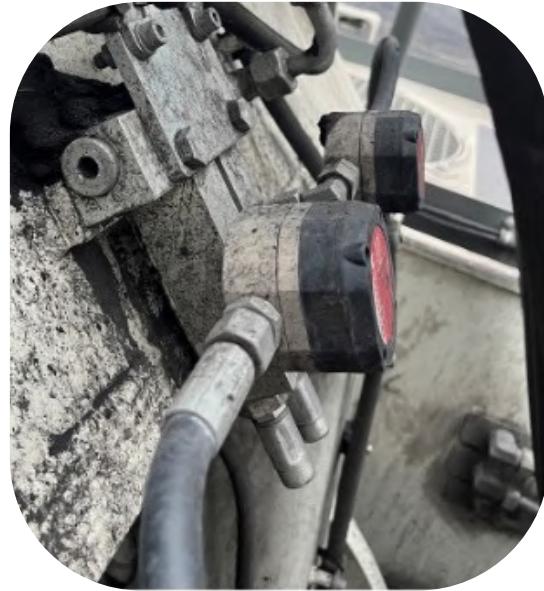
GreaseBoss implemented the Critical Point Monitoring solution, installing **12 Endpoint LF** units to monitor the boom foot & hoist cylinders, with custom made brackets.

OEM lubrication specification data was set in the GreaseBoss Cloud as the target delivery volumes. The solution provided near real-time lubrication volume data, allowing for immediate comparison of **planned vs actual greasing volumes** to the OEM specification.

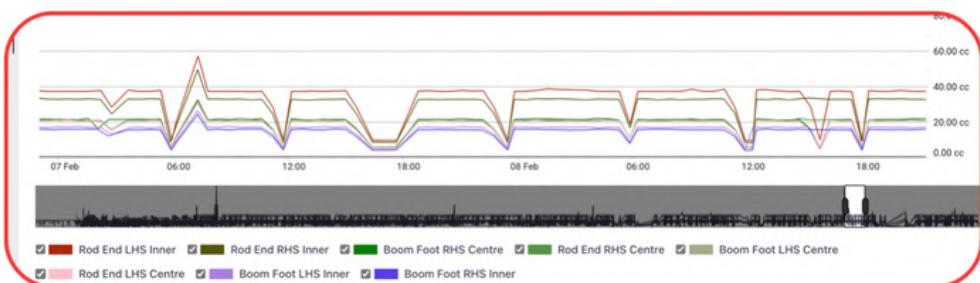
HEALTHY LUBE SYSTEM

Below is the “healthy” lube system showing all monitored grease points trending together.
