ELIMINATING AU\$25m DOWNTIME AT A TIER 1 GOLD MINING COMPANY

In the first three months post deployment, GreaseBoss Critical Point Monitoring solution on a Tier 1 gold mine's SAG mill **discovered mistimed pumping, severe under greasing** at feed end bearings, and a pinion injector failure, enabling immediate work orders, closing compliance gaps, **preventing a potential mill failure, costing AU\$25m in lost production.**

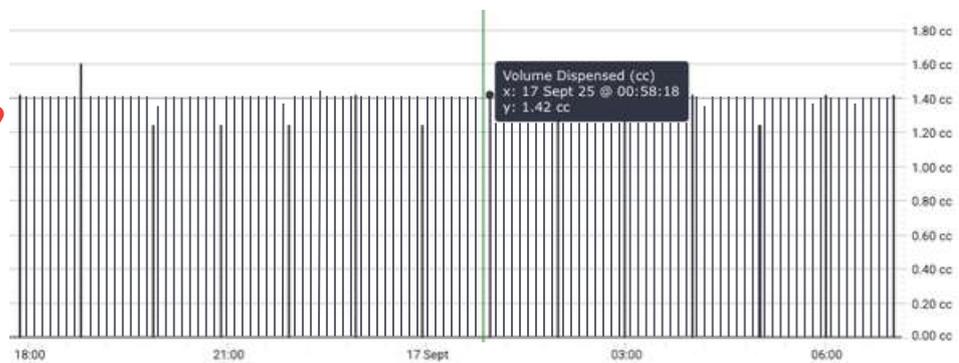
EXPECTED GREASE DELIVERY

The customer was expecting a grease delivery of **1.2 grams every 435 seconds**, which adds up to 9.93 grams per hour. However, **our data revealed that the pump is only firing 1.2 grams per hour,**

delivering only 12% of the target grease volume.

9.93g/hr

This visibility over planned vs actual greasing allowed our customer to raise work orders and immediately remedy the pump before any critical failures occur.

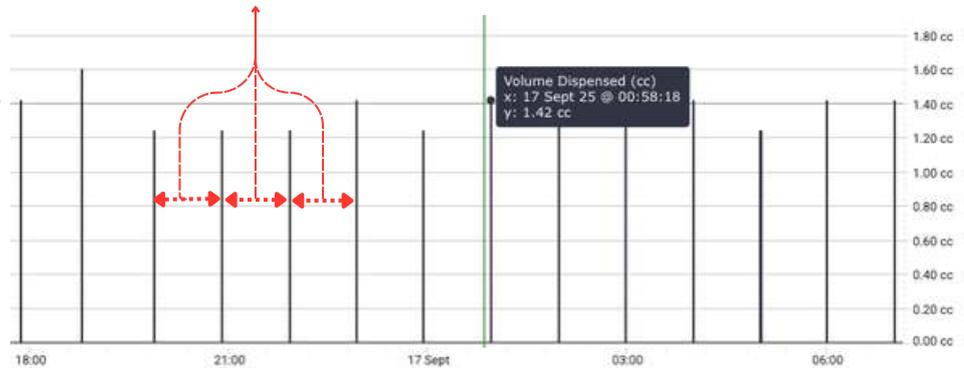
ACTUAL GREASE DELIVERY

ONE HOUR GAPS BETWEEN GREASE EVENTS

1.20g/hr

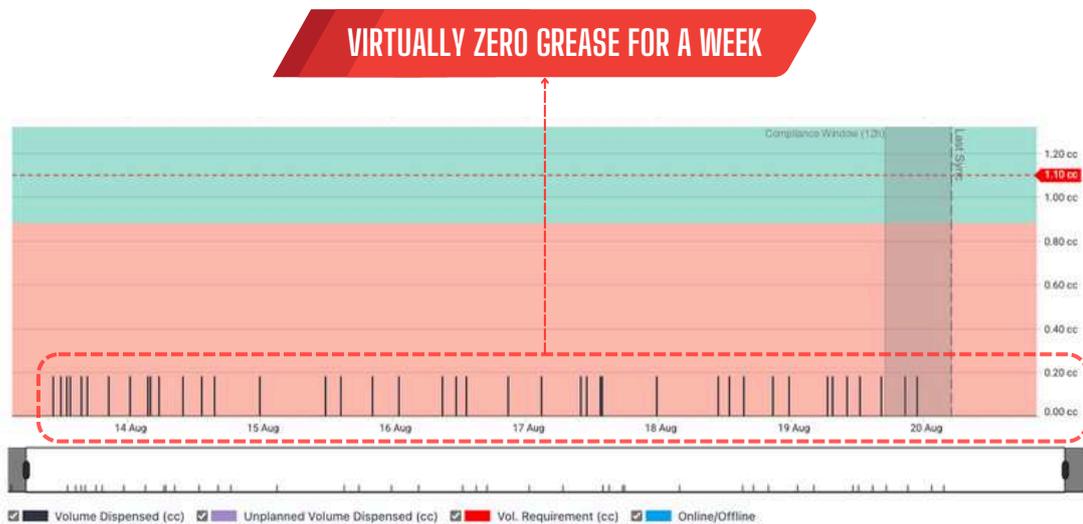
2. UNCOVERED SEVERE UNDERGREASING ON FEED END LEFT & RIGHT

The GreaseCloud data successfully indicated that both **Feed End Left and Right show near-zero grease delivery** over the review window, indicating these bearings are not receiving lubrication and at high risk of premature failure.

This visibility prompted the customer to take a prescriptive maintenance approach, allowing the maintenance team to schedule a planned downtime and fix the lubrication system instead of experiencing a major unplanned shutdown.

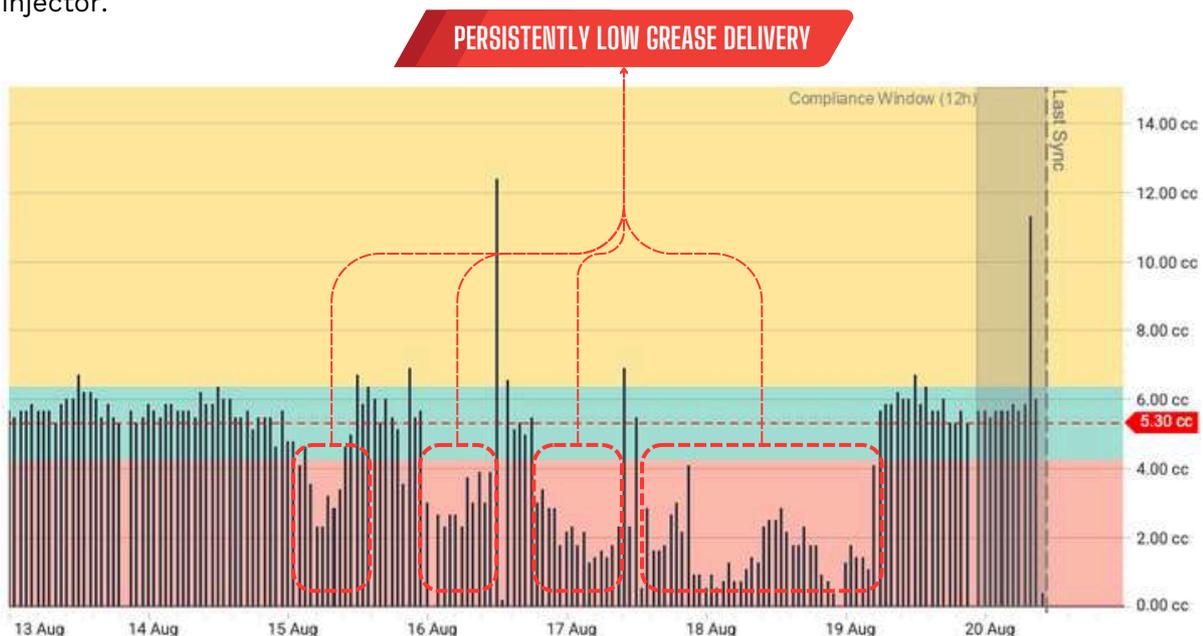
3. REVEALED SIGNS OF INJECTOR FAILURE ON DRIVE END PINION BEARINGS

The Drive End pinion shows a **pattern of persistently low/declining volumes across multiple cycles**, consistent with signs of injector failure.

This behaviour indicated **early stages of injector failure**, where partial or inconsistent delivery occurs before complete failure. This data trend was identified by the GreaseBoss team and raised with the maintenance team, who immediately raised a work order to replace the failing injector.

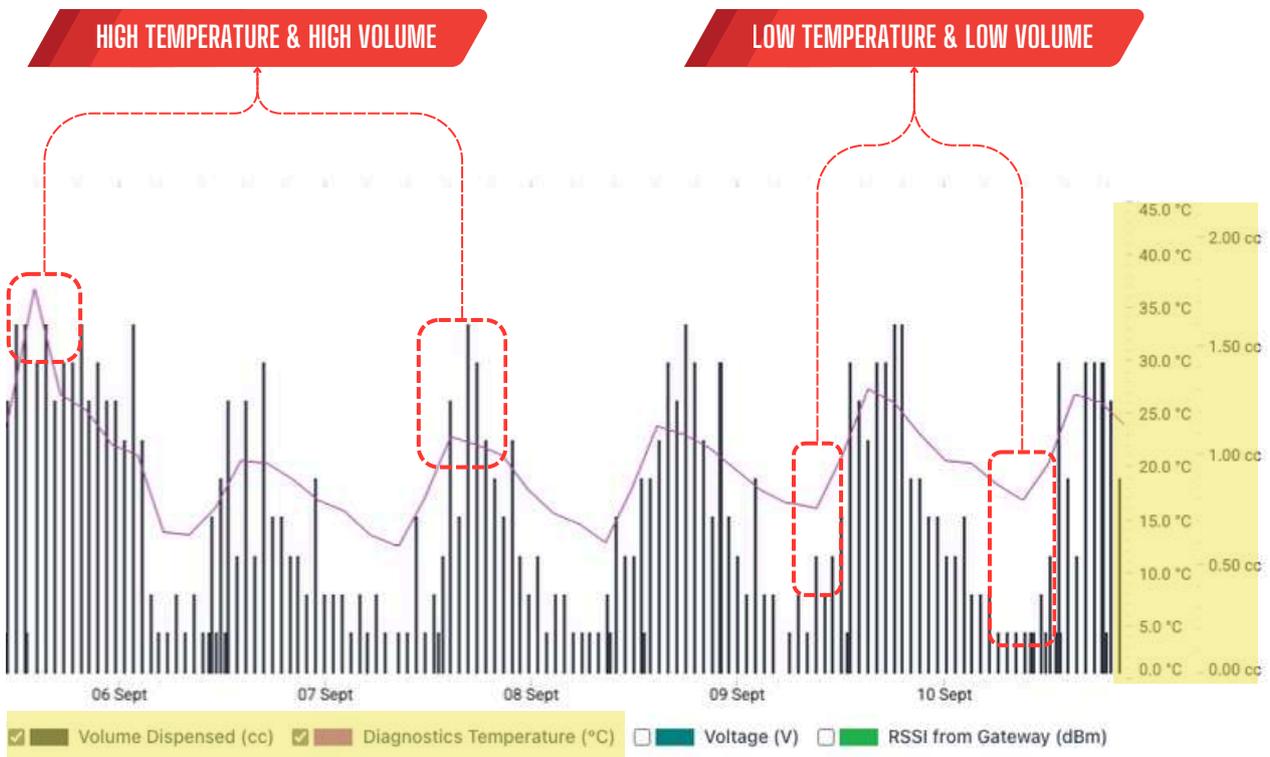
4. INDICATED TEMPERATURE-DRIVEN GREASE VARIABILITY

The system also clearly **identified the impact that daily temperature fluctuations had on the grease delivery volumes** into the mill. The data demonstrated that **the mill was consistently being undergreased during colder hours.**

This data enables maintenance teams to properly assess the effectiveness of any grease heating systems on site and the potential for a different grease type to be used.
